Shine Wire Products, Inc.

Test report

The report presents test results from a High Current conducted test on WXGuard lightning diverters utilizing 0.125 inch diameter buttons.

Report No.: 20313-07 V3_0

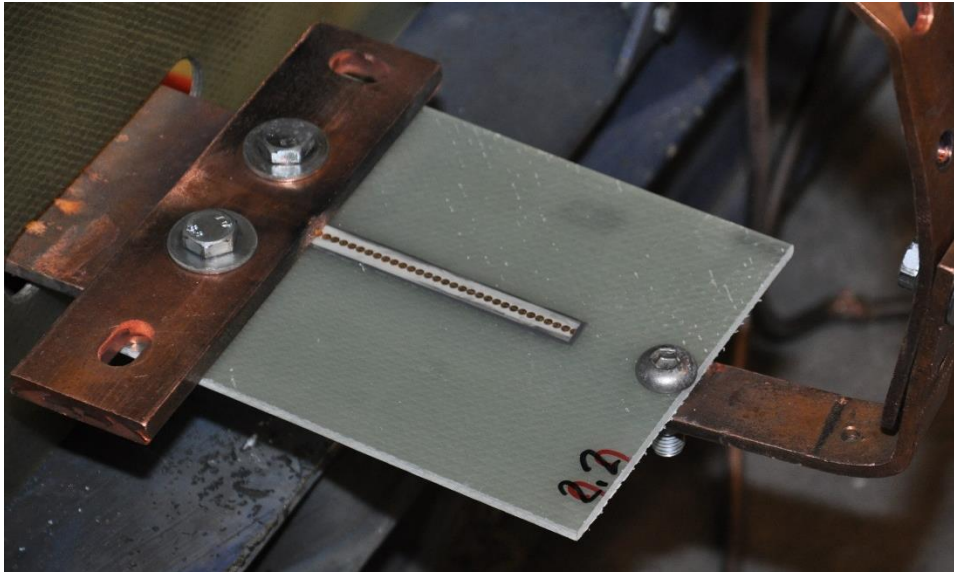
Figure 1 – Test sample 1 installed to the generator, 10 cm diverter strips section attached on a glass fibre panel with 1-inch gap in one end.

Three samples of 10 cm diverter strip with round 0.125 inch button, placed with 1 inch gap from where the arc initiates are tested. Each of the samples are connected to the test generator as seen on Figure 1, where the high terminal of the generator is connected to the bolt on the right side, and the low terminal is connected directly to the lightning diverter.

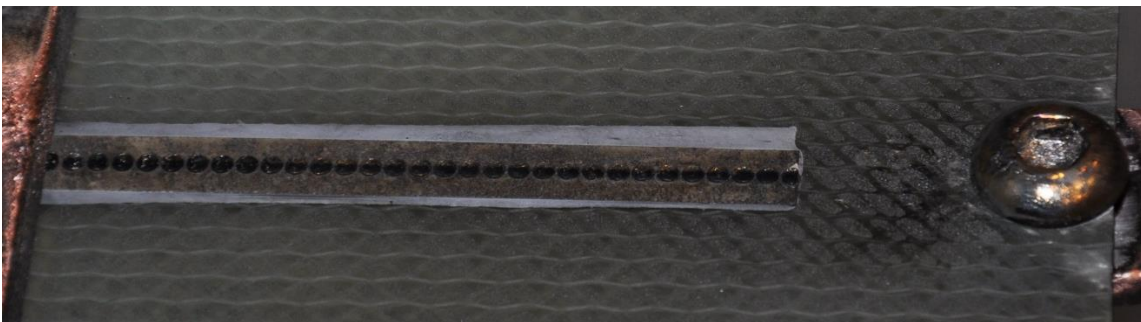
Figure 4 – Sample 2 after all three tests, with all buttons intact.
